Report: 1947-10

**Confidential Inspection Report  
123 Main St  
Hampton, VA**

**June 30, 2018**

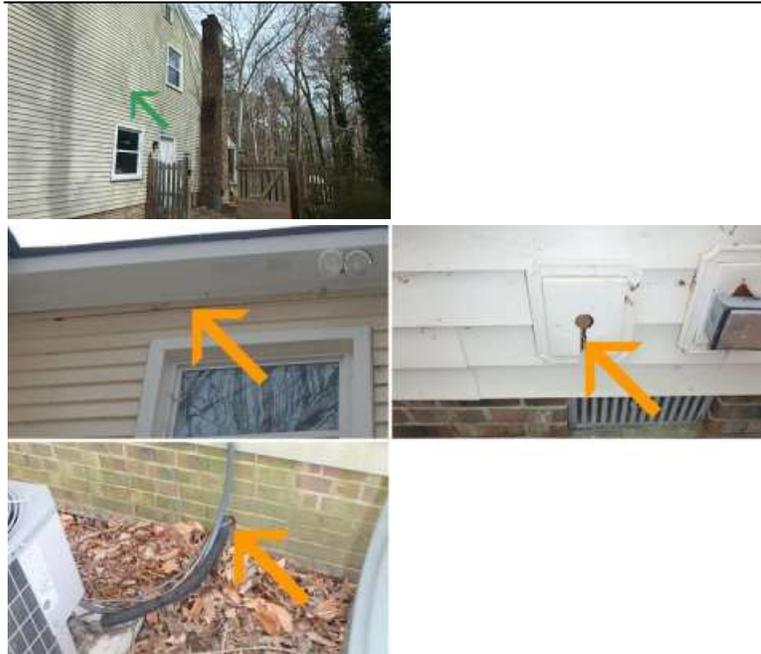
#### **2.2 Maintenance Condition:**

**There is some loose siding noted at the rear of the home.**

**Have the siding secured properly to prevent moisture or insect intrusion.**

**Caulk around any holes, gaps, and penetration points to avoid moisture and insect intrusion.**

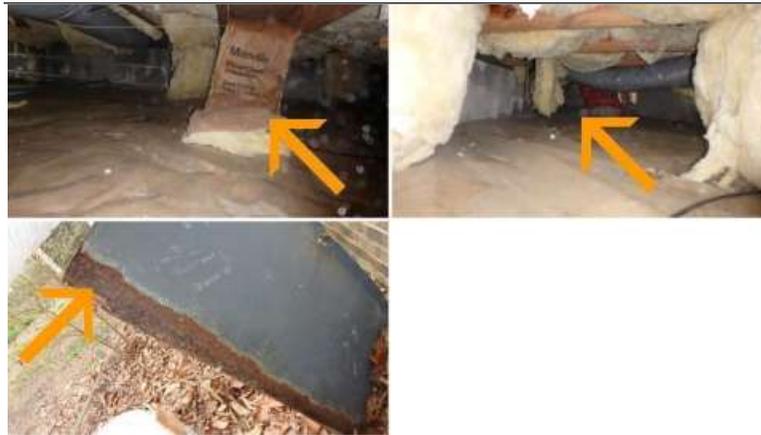
*2.8 Maintenance Condition:*

Have the insulation re-secured in the crawl space where fallen to provide a proper thermal barrier. The crawl space door is deteriorated and rusty. It is important to have the access door made of stable exterior material and properly secure door to the foundation wall.

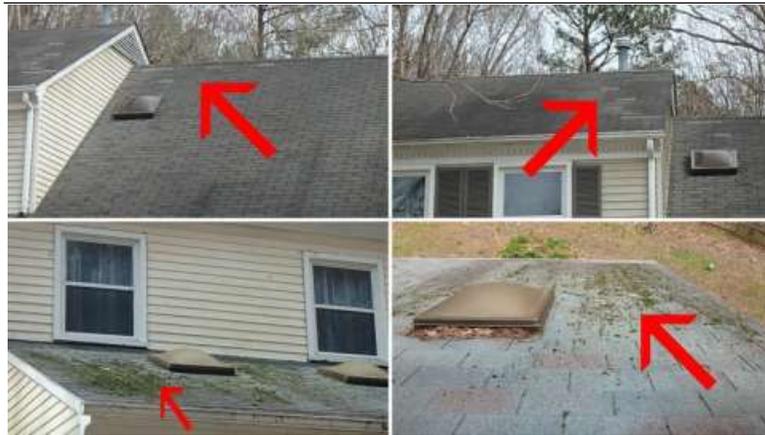
**3.9 Immediate Concerns Condition:**

**There are broken shingle tabs noted at the roof, some repairs have been made however some are still lifted/not properly secured.**

**Remove the moss/debris noted at the roof surface at time of inspection.**

**Have a licensed and insured roofing contractor evaluate and make any further recommendations or repairs as needed to the roofing system.**

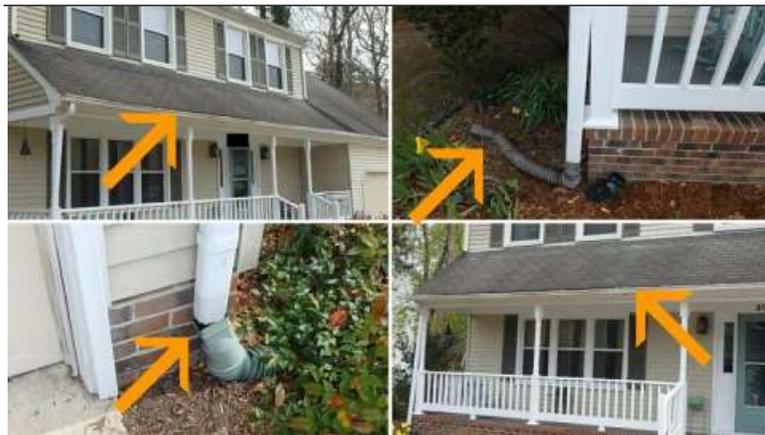
**3.11 Condition:**

**Clean the debris from gutter and secure as needed as part of standard maintenance. At this time gutters are partially clogged/clogged and could hold water and back up under the shingles.**

**There are portions of the gutter system that are loose at time of inspection in the front of the home and on the left front of the home.**

**Secure the gutters and/or downspouts to the house as needed to ensure proper function.**

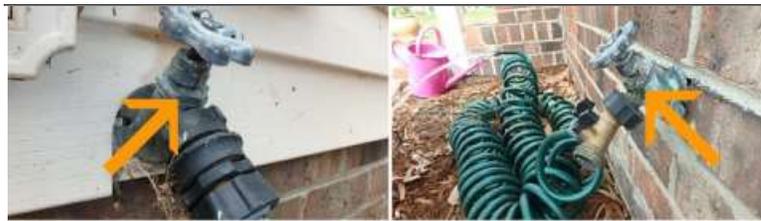
*4.6 Maintenance Condition:*

The hose faucets at the front and rear of the home have leaking stems noted. Repair/replace as needed for proper function.

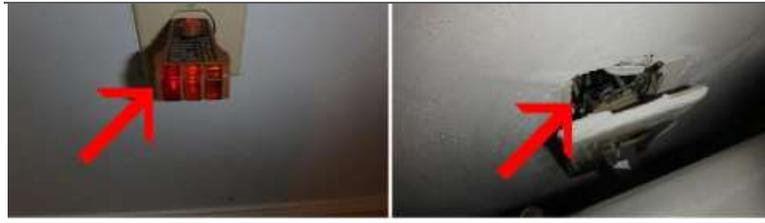
#### **6.4 Immediate Concerns Switches/Outlets;**

**The outlet in the upstairs back left bedroom has the hot and neutral reversed, repair/correction is needed.**

**Secure the outlet behind the washing machine as needed.**

**Have a licensed and insured electrical contractor further evaluate and make any recommendations and repairs as needed to the electrical system.**

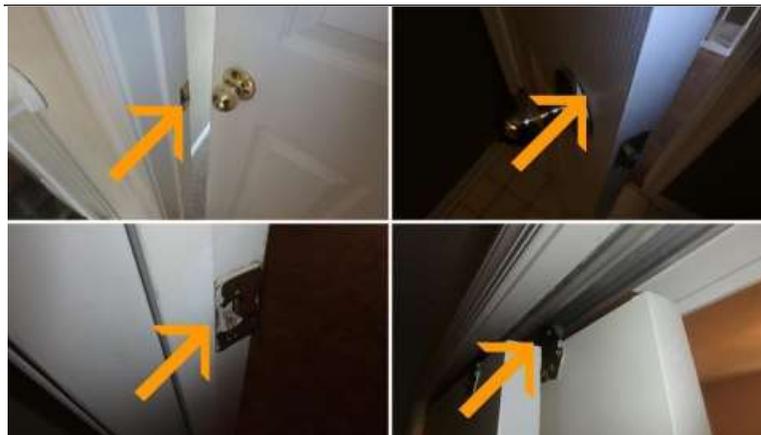
**Damage is noted to some of the doors have repaired or replace as needed.**

**There are some interior doors that need to be adjusted so to latch properly.**

**Add door stops to doors where missing around the house to avoid damage to the walls and doors.**

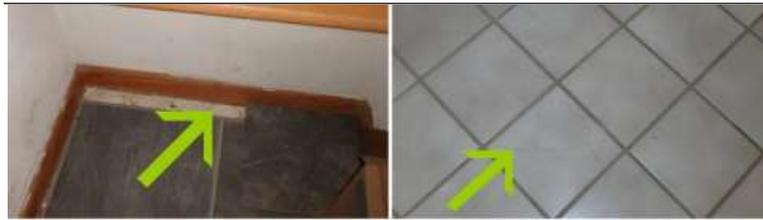
*7.12 Cosmetic Condition*

**There are squeaks noted in the sub-flooring. Squeaks are caused when the subfloor begins to separate from the floor joists. The nails squeak as they slide in and out of the joists. At time of inspection, the vinyl tiles have not been completely installed. Complete and inspect for proper insulation.**

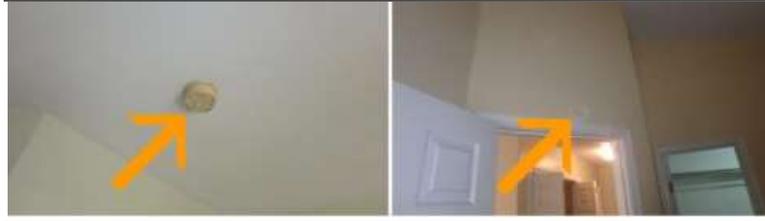
**There are some units that are missing and need to be replaced, Smoke detectors should be installed in each bedroom and in both upper and lower hallways for maximum safety. Testing for proper operation and installation of fresh batteries yearly is recommended.**

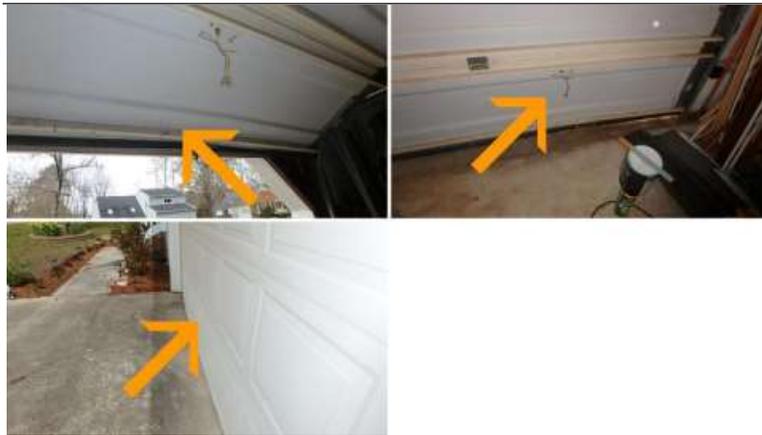
#### **8.5 Main Garage Door(s):**

**The main garage door is bent at the bottom, this is causing the door to bow out. Repair/replace as needed.**

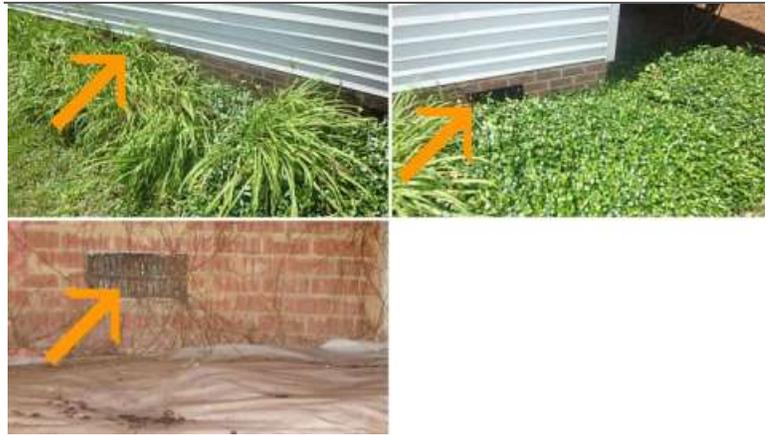
#### 11.5 Condition:

It is recommended to trim away bushes, plants and/or ivy away from structure to help prevent damage to the building materials.
