HOME INSPECTIONS

RE: 123 Main Street
Anywhere , USA

IMMEDIATE DEFICIENCIES

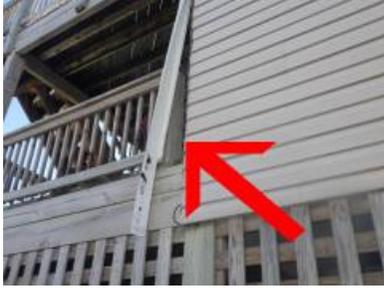
2.3 Immediate Concerns:

Secure/repair the loose vinyl corner seen on the back left of the house.

Secure properly so not to blow off and allow damage to happen to the house.

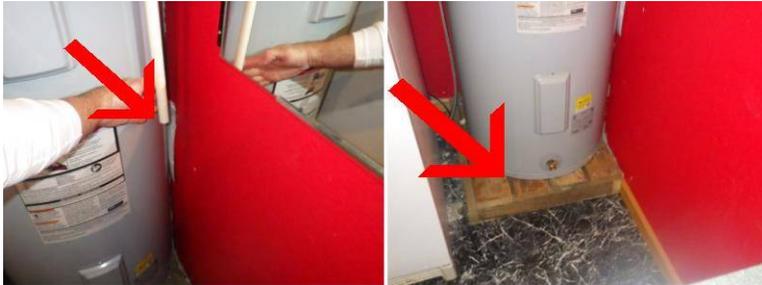
4.12 Immediate Concerns Condition:

The unit is missing the required drain pan and the TPR pipe does not extend to the base of the unit, have installed for safety. Have a licensed and insured plumbing contractor evaluate and make any further recommendations or repairs as needed to the plumbing system.

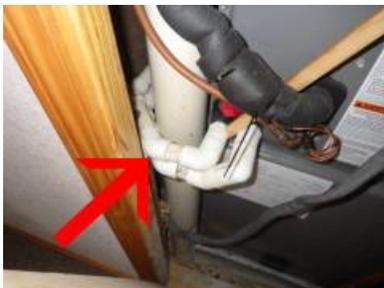
5.23 Immediate Concern Condition:

The required secondary condensate shutoff switch and p-trap are missing.

This will keep the condensate drain water from draining onto the ceiling below in case of a leak. Have a licensed and insured HVAC contractor further evaluate and make any recommendations and repairs as needed to the HVAC system.

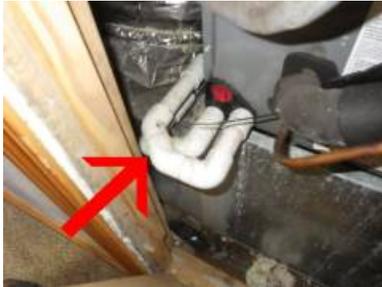
5.30 Immediate Concern Condition:

The required secondary condensate shutoff switch and p-trap are missing.

This will keep the condensate drain water from draining onto the ceiling below in case of a leak. Have a licensed and insured HVAC contractor further evaluate and make any recommendations and repairs as needed to the HVAC system.

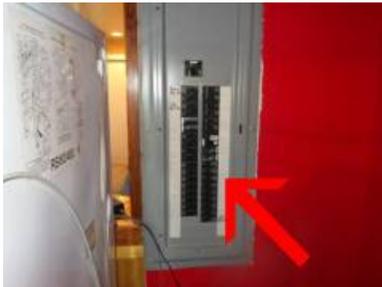
6.4 Immediate Concerns For Panel:

The panel is missing the breaker cover as required for safety, have the cover found and installed or replace with new cover/door.

Have a licensed and insured electrical contractor further evaluate and make any recommendations and repairs as needed to the electrical system.

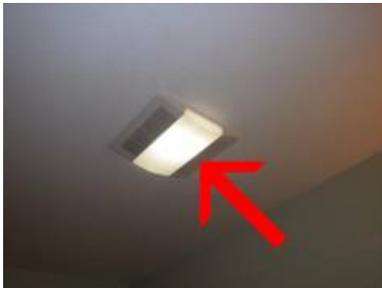
10.12 Bath Ventilation:

The fan blades in the vent in bathroom #2 are not spinning.

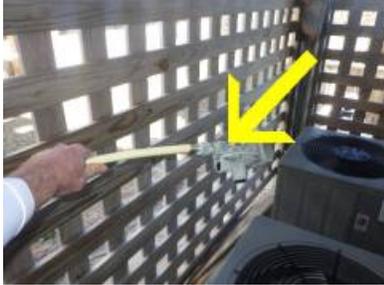
1.16 Other Utilities/Systems:

A propane tank line is present but no tank. The gas fireplace is the only gas appliance.

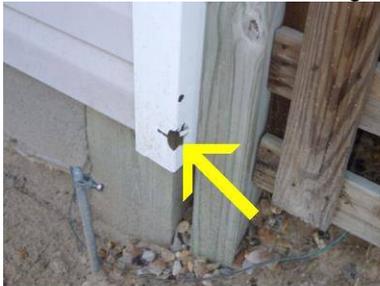
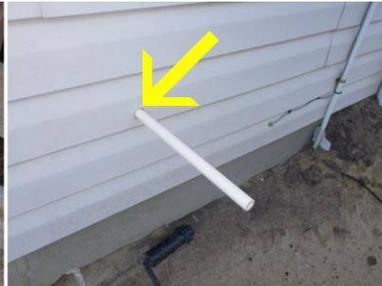
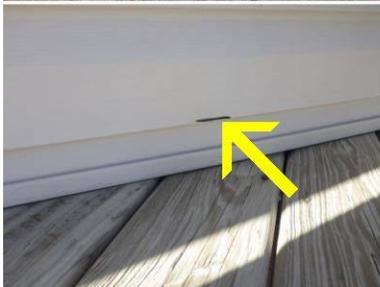
2.2 Maintenance Condition:

Caulk around the A/C lines and any holes, gaps, or penetration points to avoid moisture and insect intrusion. Small crack noted in the siding on the third floor deck base, have sealed to prevent moisture intrusion.

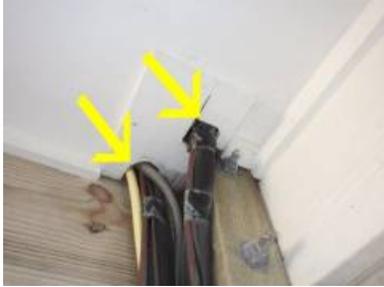
2.5 Maintenance Condition:

Seal around the pipes and lines that enter the house by way of the carport ceiling to prevent moisture/pest intrusion.

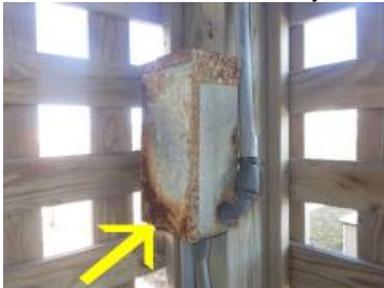
5.7 Maintenance Condition:

Have the A/C lines re-insulated where missing to reduce condensation and for a proper thermal barrier. The disconnect box is rusty, scrape and paint to keep from deteriorating further/prolong life.

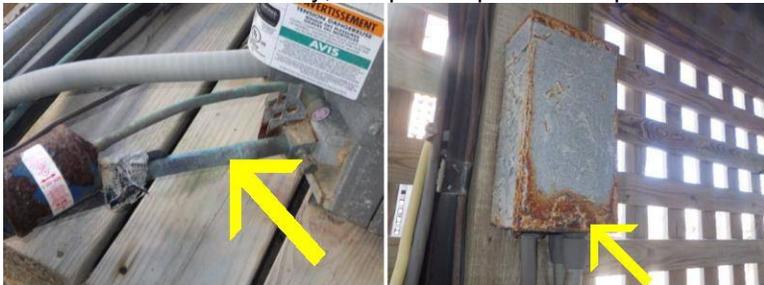
5.14 Maintenance Condition:

Have the A/C lines re-insulated where missing to reduce condensation and for a proper thermal barrier. The disconnect box is rusty, scrape and paint to keep from deteriorating further.

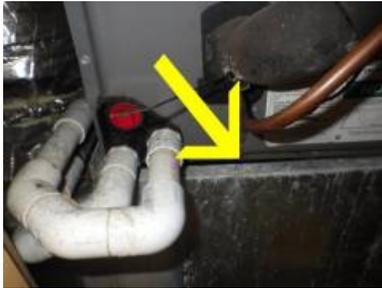
5.29 Maintenance Condition:

Re-insulate the AC line as per standard to keep from sweating to prevent damage to the ceilings below.

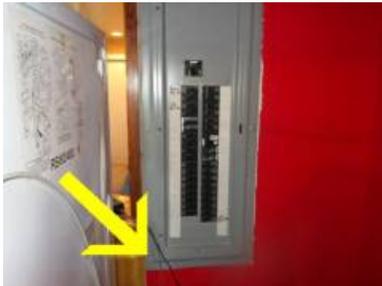
6.3 Cautionary Issues For Panel:

The location of the panel (beside the refrigerator) is not a standard location.

There are missing and/or improper sharp pointed screws in the panel cover, Have replaced to properly secure the panel to the wall and for safety.

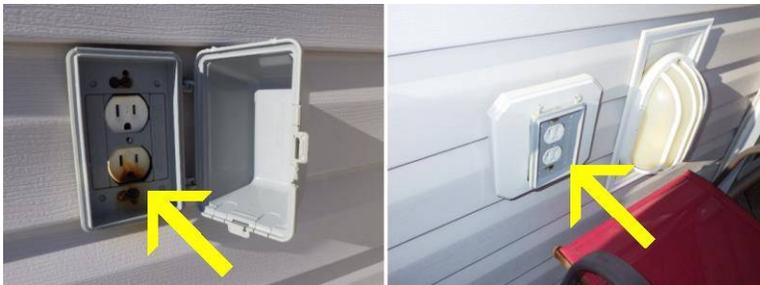
6.5 Immediate Concerns Switches/Outlets;

The back exterior second floor deck outlet cover is missing. Install for safety

The back exterior third floor deck outlet has a cracked cover and is rusted internally.

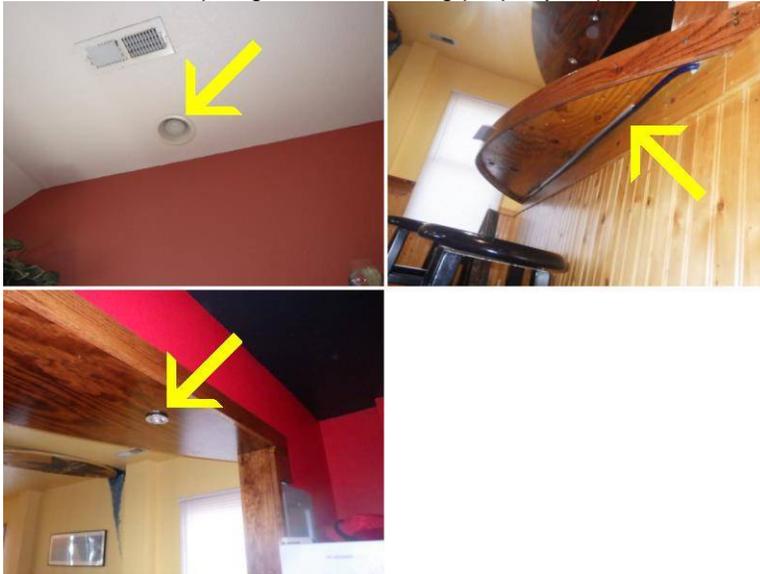
6.6 Lighting

There are some missing or blown bulbs throughout the home. Replace the bulbs and retest to ensure of operation. The bar pod light is missing a cover, replace as needed. The under bar rope light is not working properly, repair/replace.

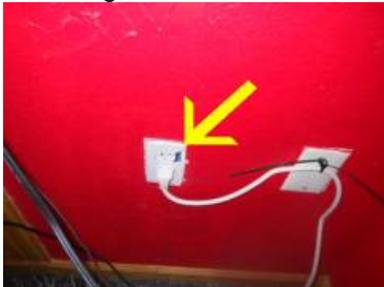
6.7 Electric

The refrigerator outlet has a broken cover, replace as needed.

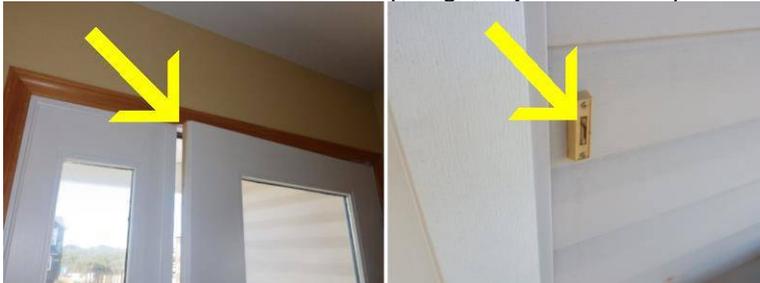
7.1 Front Door:

A door stop should be installed to the front door to prevent damage to the door and/or wall.

The door deck button is damaged, repairs are needed.

The door rubs the frame at the top edge, adjust for fluid operation.

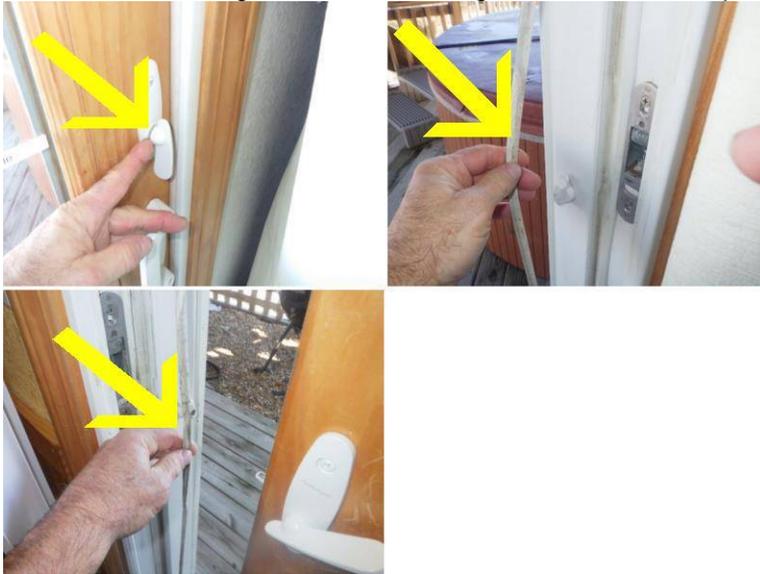
7.2 Other Exterior Doors:

The downstairs back sliding door seals are damaged, replace for a proper seal.
The second floor left bedroom door seal and lock are damaged, repair/replace.
The third floor sliding door seal is missing, add seal to form a proper seal.

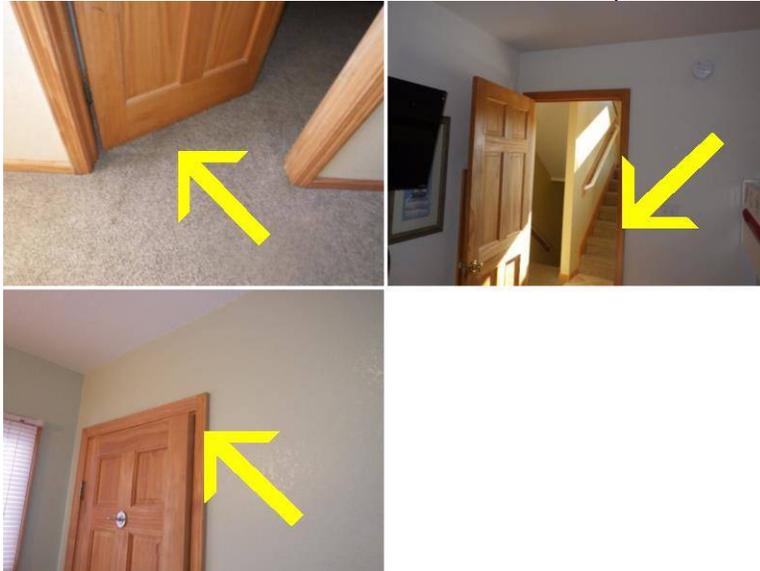
7.3 Interior Doors:

Add door stops to doors where missing around the house to avoid damage to the walls and doors.
Have the door cut for a proper 5/8 inch airflow at the carpet as is standard.
The second floor front bedroom door does not latch, adjust for proper latching.
The second floor left bedroom bathroom door is not plumb in the frame, re-work as needed.

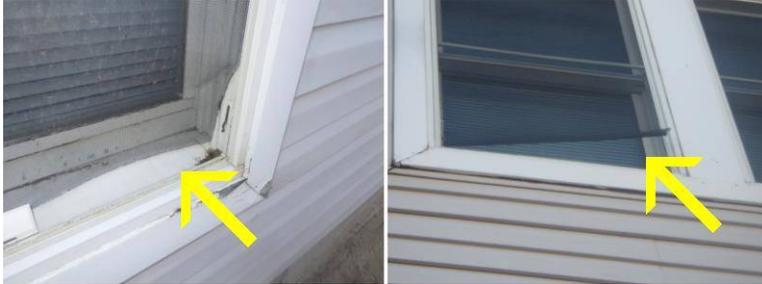
7.5 Maintenance Condition:

There are two window screen(s) that are not installed. Screen in the closet.

There are five screen(s) that have holes or damage noted around the home. Have the screens repaired or replaced as needed.

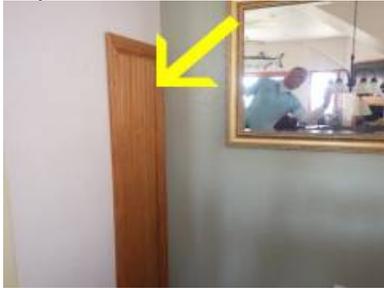
7.8 Maintenance Conditions:

Repair the HVAC access doors and trim as needed.

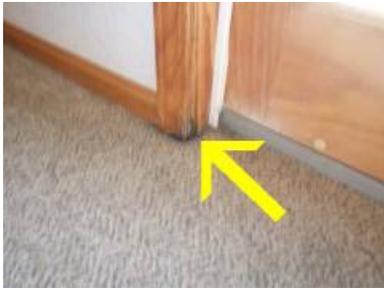
Moisture stains noted in the wall at the rear third floor door frame.

The area is dry at this time and no major damage found, just minor deterioration from water leaking in through the sliding door. Repair/paint as needed.

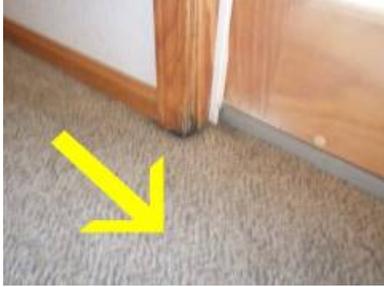
7.13 Maintenance Condition:

The floor around the upstairs sliding door area has areas that are un-level. No sub-floor damage detected, just unevenness of the carpet padding.

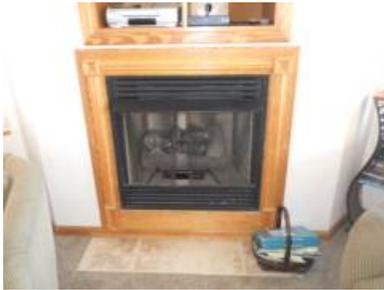
7.16 Condition:

We are unable to test the unit at the time of inspection due to the utility that operates the system/component(gas) being off. Recommend having the utility turned on, and all dependent components and systems thoroughly tested at that time.

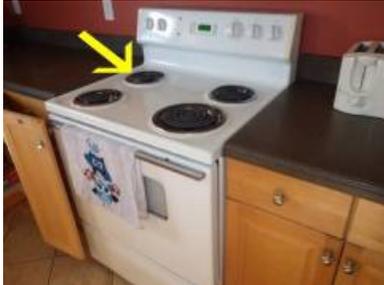
9.5 Condition:

Raise or lower the unit as needed to be level with the countertop as per manufacturers standards.

The stove has not been secured as required by manufacturer's installation instructions. A tip-over hazard exists for small children.

The stove handle is loose, secure as needed.

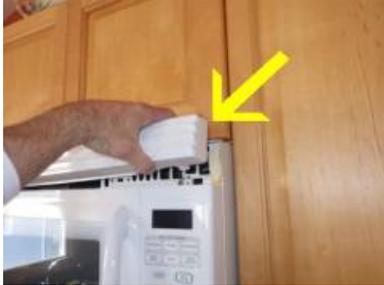
9.13 The Condition Of The Microwave Is

The units top vent louver, is damaged and held only on by tape. This is not a issue but cosmetic in nature.

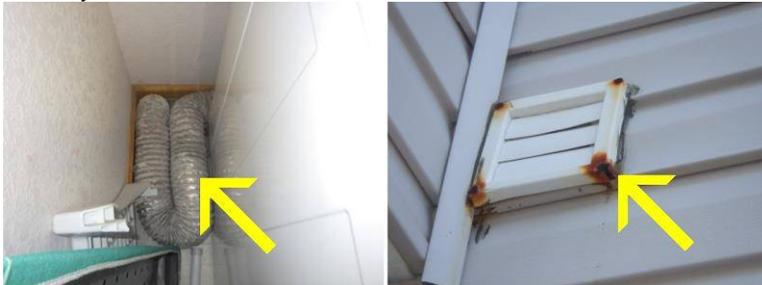
9.17 Condition:

It is important to clean and maintain the dryer venting to prevent a fire hazard.

The dryer vent louver fasteners are noted to be rusted.

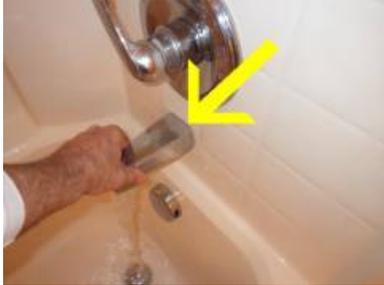
10.4 Tub/Shower Plumbing Fixtures:

The tub/shower fixtures in bathroom #1 need to be caulked to prevent moisture intrusion.

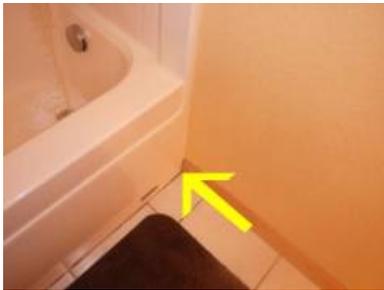
10.5 Tub/Shower And Walls:

Caulking is needed at the tub to the floor in bathroom #1 to avoid moisture intrusion.

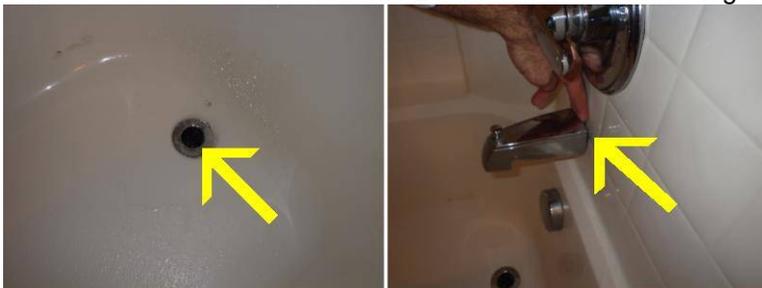
10.10 Tub/Shower Plumbing Fixtures:

The tub/shower fixtures in bathroom #2 need to be caulked to prevent moisture intrusion.

The tub drain basket in bathroom #2 is rusted out and can clog easily.

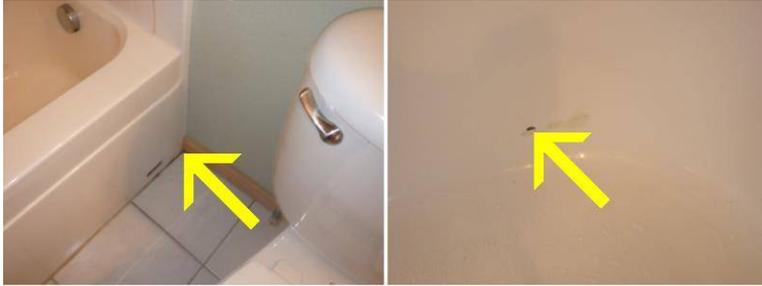
10.11 Tub/Shower And Walls:

Caulking is needed at the tub to the floor in bathroom #2 to avoid moisture intrusion. Holes noted in the gel coat in bathroom #2.

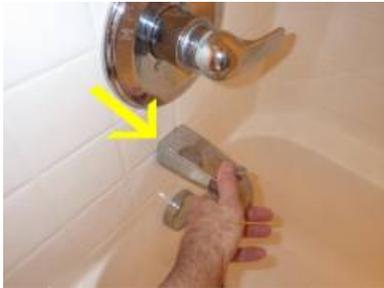
10.16 Tub/Shower Plumbing Fixtures:

The tub/shower fixtures in bathroom #3 need to be caulked to prevent moisture intrusion.

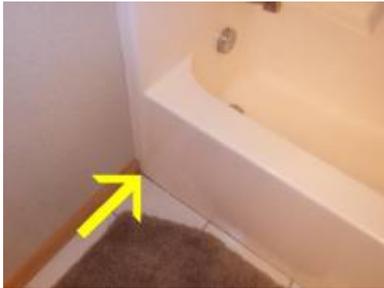
10.17 Tub/Shower And Walls:

Caulking is needed at the tub to the floor in bathroom #3 to avoid moisture intrusion.

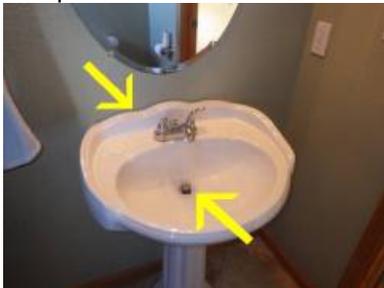
10.20 Condition Of Sink:

The sink is slow to drain in bathroom #4. Have the drain unclogged as needed to ensure proper drainage. The pedestal sink is loose from the wall.

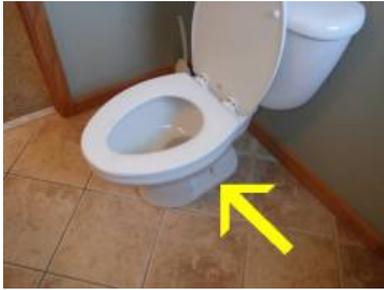
10.21 Condition Of Toilet:

The toilet in bathroom #4 needs to have the wax ring replaced and toilet secured. This will ensure that there are no leaks, which can cause moisture damage that is hard to detect.

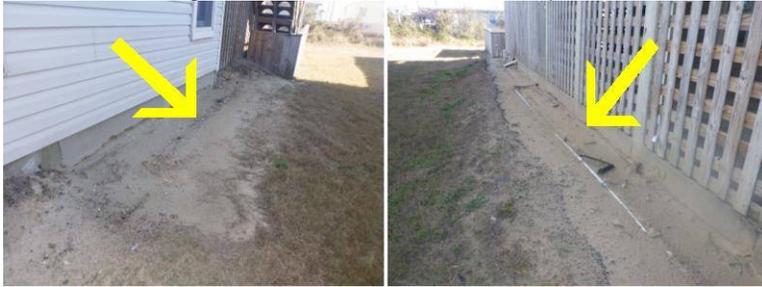
11.7 Condition:

Install rock along the sides of the house to keep the soil from washing out.

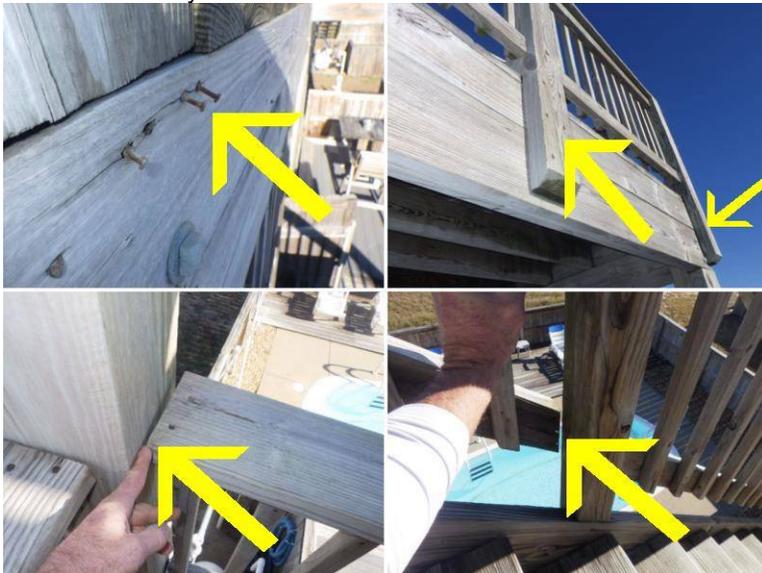
11.11 Condition:

Hammer in all loose nails in the deck to secure the structure.

It is standard for the deck posts and rails to be bolted down for safety. Loose railing noted on the third floor steps, secure for safety.

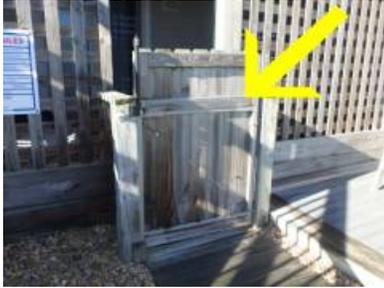
11.14 Condition:

Have the gates adjusted so operate smoothly and latch properly.

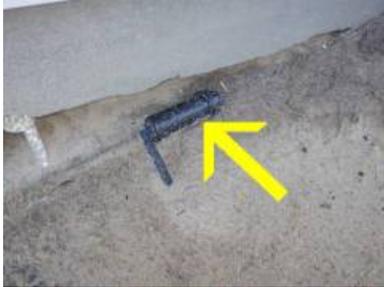
11.16 Sprinkler System

Some heads are laying on the ground and need to be reworked and serviced come spring/before first use.

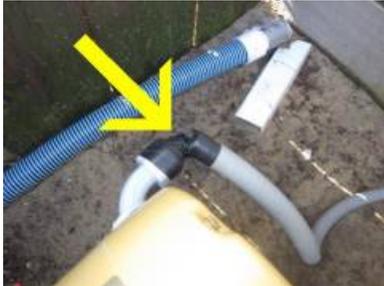
12.7 Pump & Motor:

The electrical wire feed conduit has come loose from the motor and electrical tape is wrapped around it. Recommend re-working the conduit to be properly secured for safety.

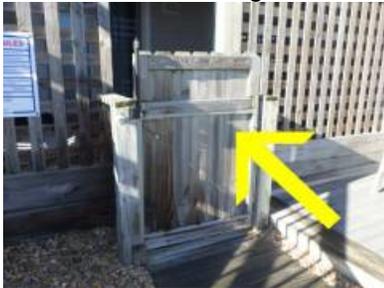
12.12 Overall Condition:

Recommend installing a closer on the pool gates so they will close automatically, for safety.

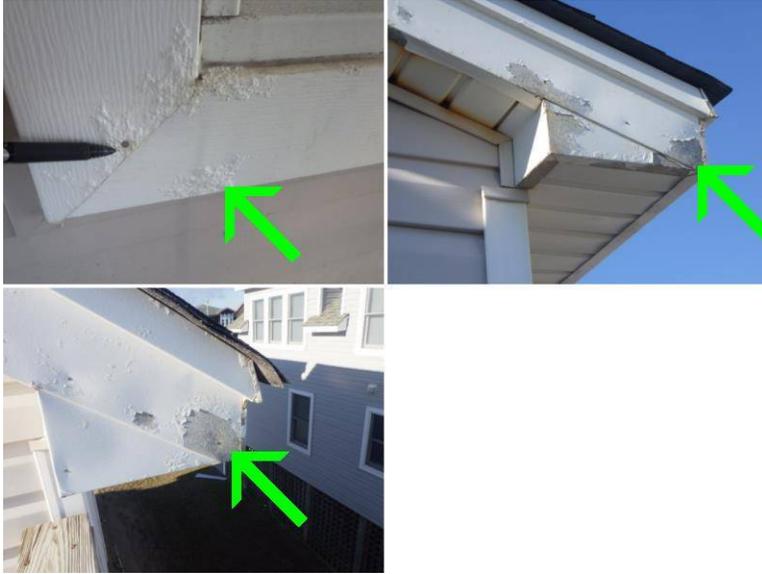
2.5 Maintenance Condition:

Minor deterioration noted to the metal wrapping around the home, monitor.

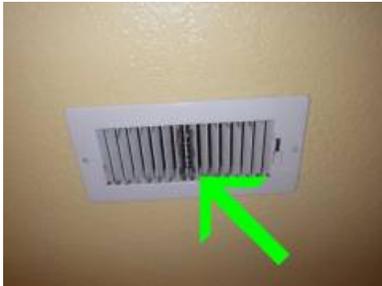
5.16 Condition:

There is a small amount of black stain on the ceiling vents around the house. Cleaning of these vents is a part of routine maintenance and should be done at this time.

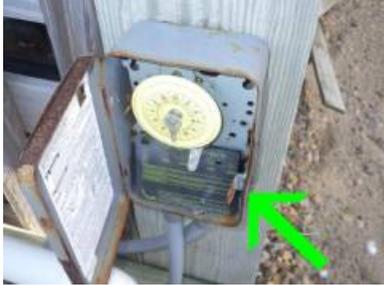
12.10 Timers:

The timer box is rusty, but works.
