HOME INSPECTIONS

RE: 123 Main St
Hampton, VA

IMMEDIATE DEFICIENCIES

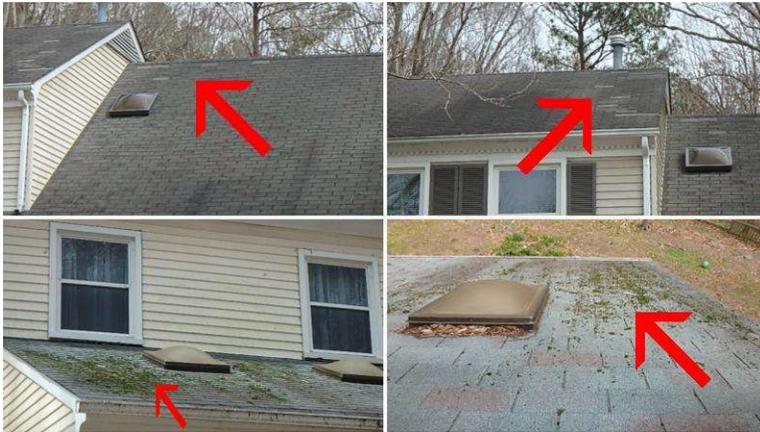
3.9 Immediate Concerns Condition:

There are broken shingle tabs noted at the roof, some repairs have been made however some are still lifted/not properly secured.

Remove the moss/debris noted at the roof surface at time of inspection.

Have a licensed and insured roofing contractor evaluate and make any further recommendations or repairs as needed to the roofing system.

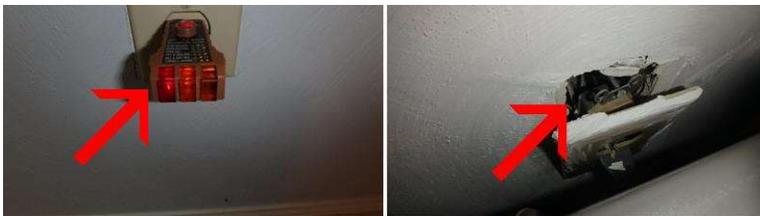
6.4 Immediate Concerns Switches/Outlets;

The outlet in the upstairs back left bedroom has the hot and neutral reversed, repair/correction is needed.

Secure the outlet behind the washing machine as needed.

Have a licensed and insured electrical contractor further evaluate and make any recommendations and repairs as needed to the electrical system.

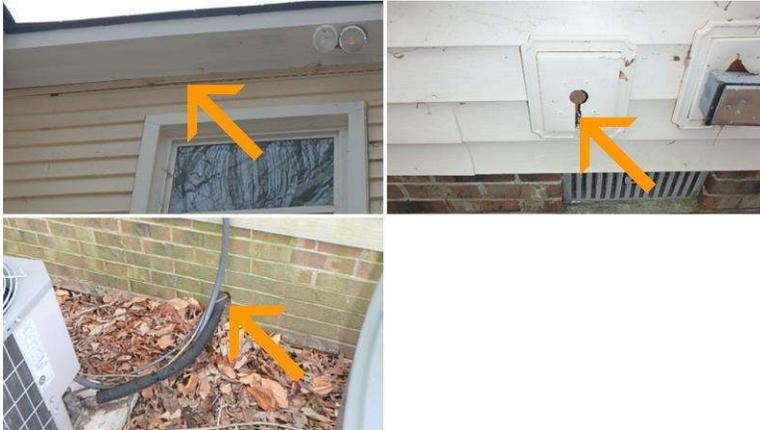
2.2 Maintenance Condition:

There is some loose siding noted at the rear of the home.

Have the siding secured properly to prevent moisture or insect intrusion.

Caulk around any holes, gaps, and penetration points to avoid moisture and insect intrusion.

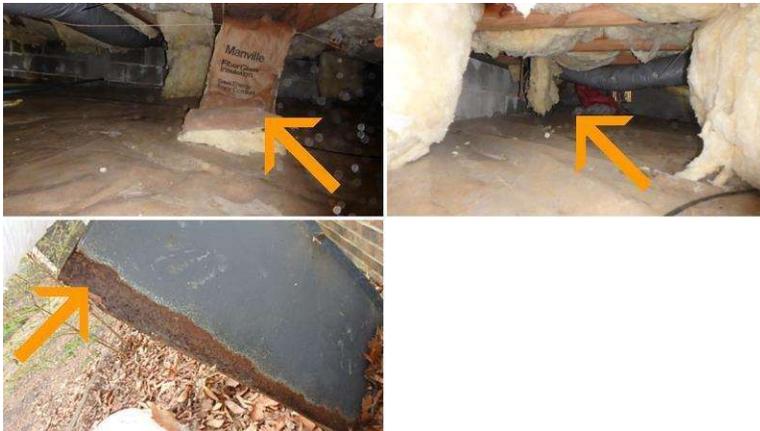
2.8 Maintenance Condition:

Have the insulation re-secured in the crawl space where fallen to provide a proper thermal barrier.

The crawl space door is deteriorated and rusty. It is important to have the access door made of stable exterior material and properly secure door to the foundation wall.

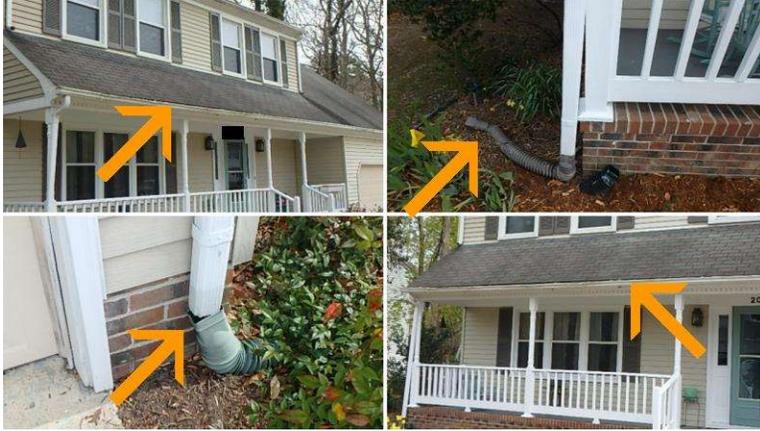
3.11 Condition:

Clean the debris from gutter and secure as needed as part of standard maintenance. At this time gutters are partially clogged/clogged and could hold water and back up under the shingles. There are portions of the gutter system that are loose at time of inspection in the front of the home and on the left front of the home. Secure the gutters and/or downspouts to the house as needed to ensure proper function.

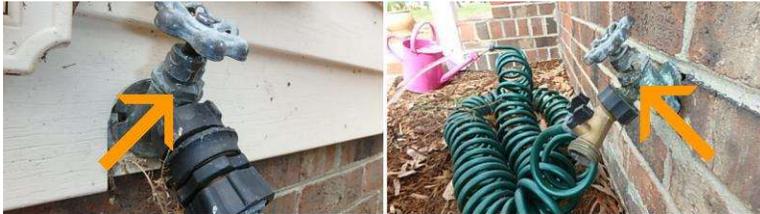
4.6 Maintenance Condition:

The hose faucets at the front and rear of the home have leaking stems noted. Repair/replace as needed for proper function.

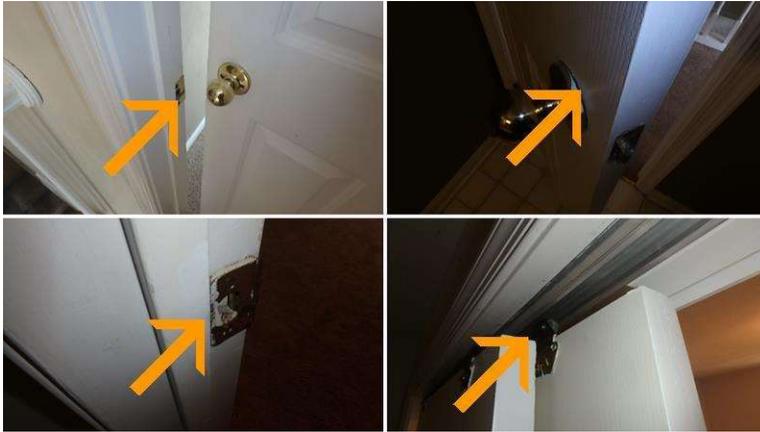
7.3 Interior Doors:

The strike plate need to be adjusted to allow for proper operation.

Damage is noted to some of the doors have repaired or replace as needed.

There are some interior doors that need to be adjusted so to latch properly.

Add door stops to doors where missing around the house to avoid damage to the walls and doors.

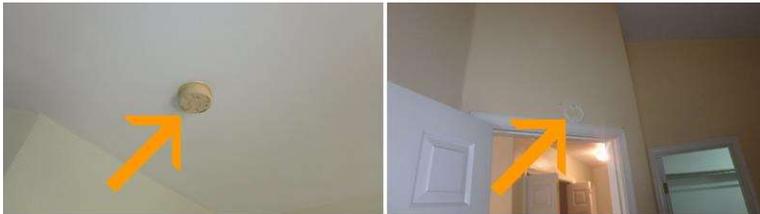
7.17 General:

There are some units that are missing and need to be replaced, Smoke detectors should be installed in each bedroom and in both upper and lower hallways for maximum safety. Testing for proper operation and installation of fresh batteries yearly is recommended.

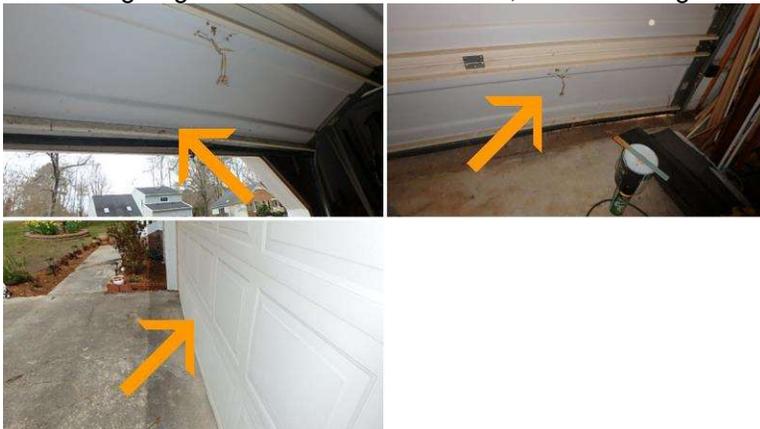
8.5 Main Garage Door(s):

The main garage door is bent at the bottom, this is causing the door to bow out. Repair/replace as needed.

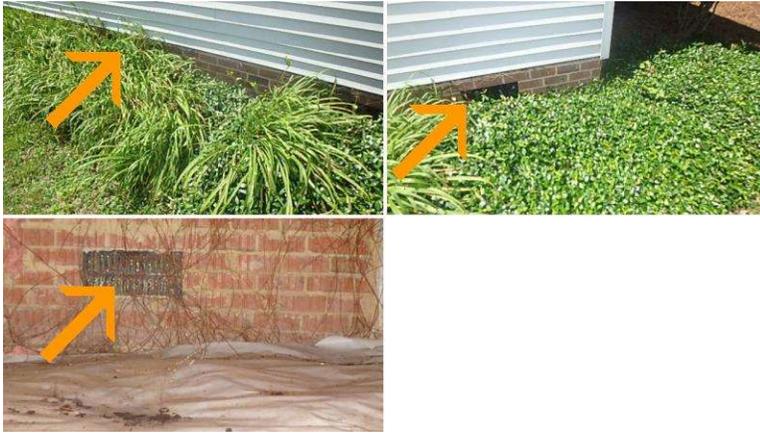
11.5 Condition:

It is recommended to trim away bushes, plants and/or ivy away from structure to help prevent damage to the building materials.

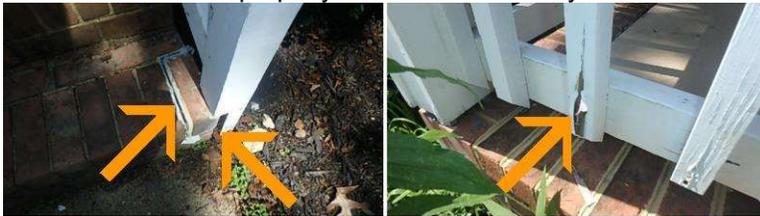
11.14 Condition:

Scrape and paint the railings as needed at the exterior steps/stoops. Point up the steps where needed to prevent moisture intrusion and further damage.

Secure the handrail properly as needed for safety.

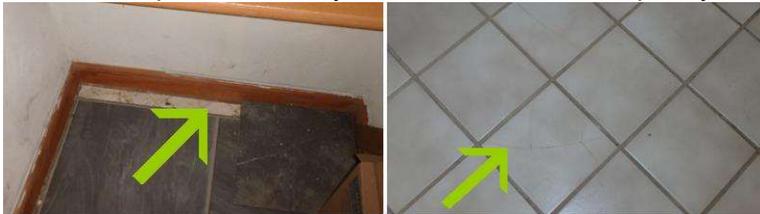
7.12 Cosmetic Condition

There are squeaks noted in the sub-flooring. Squeaks are caused when the subfloor begins to separate from the floor joists. The nails squeak as they slide in and out of the joists.

At time of inspection, the vinyl tiles have not been completely installed. Complete and inspect for proper insulation.
