Report: 1947-10

**Confidential Inspection Report  
123 Main St  
Hampton, VA**

**June 30, 2018**

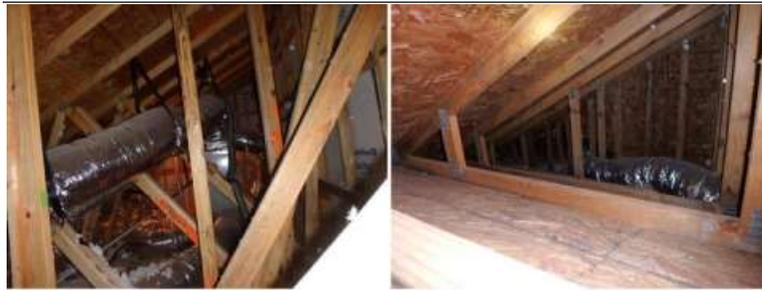
#### **3.1 Structure:**

The attic/roof structure utilizes truss framing for the structure of this roof.  
The attic is full, this means that it spans the entire area of the house.

**The attic appears to be in functional condition at time of inspection.**

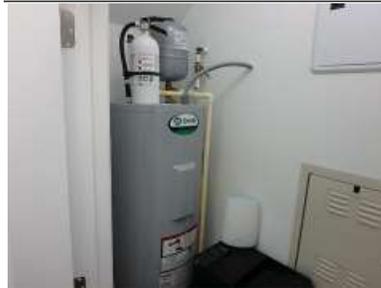
The water heater is manufactured by A.O. Smith.

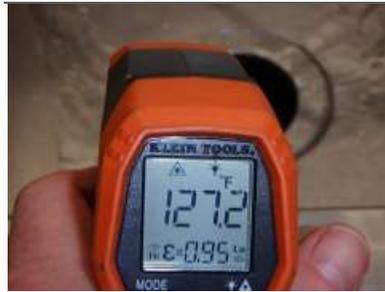
The water temperature was tested, at the time of inspection it was found to be within the manufacturers recommendations.

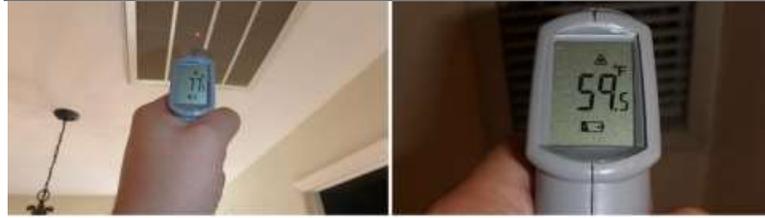
Supply Temperature-77°  
Temperature Differential- 18°  
The temperature differential noted for the unit is okay at time of inspection.

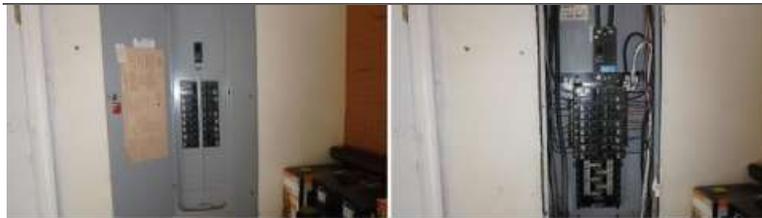
#### **6.2 Panel Location**

The main service entering the house is a 200 AMP breaker panel and is located in the garage.

The panel box appears serviceable and was standard for the year it was installed with no issues noted.
